Remedial Goal Achieved in a Single Terramend[®] Reagent Application

Soil Remediation from Roadside Crude Oil Tanker Rollover

Site Overview

Site: Former Main Roads Gravel Pit Borrow Site Purpose: Remediate Soils for Gravel Pit Rehabilitation

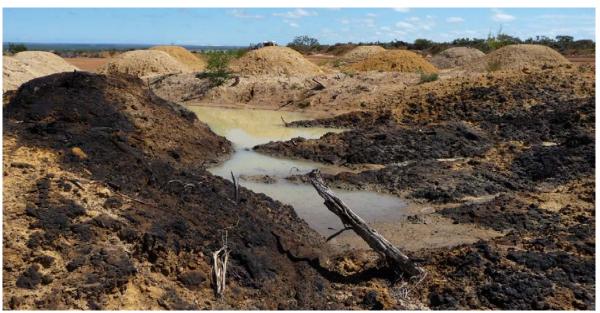
Stockpiled Soil Prior to Treatment

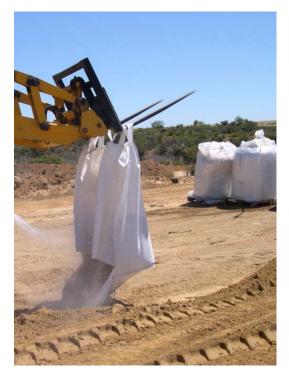
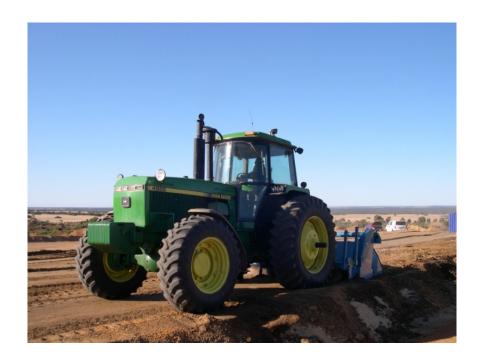
As is typical with Terramend[®] Reagent soil treatment projects, the soil was tilled prior to product incorporation. The initial target Terramend[®] Reagent dosage was 2.5% w/w on a dry soil basis, with an additional, optional 0.5 wt.% to be applied after several months as and if needed. Site conditions were very windy at the time of initial product application. As a result, approximately one-third of the product was added to the soil with very small amounts of water to 'tackify' the surface in strong winds (25 knots), rather warm temps (35° C), and drying conditions (very low humidity).

Once the Terramend[®] Reagent was tilled in, moisture content was adjusted towards the goal of approximately 60% of the soil's water holding capacity (WHC).

Although a few project challenges occurred (difficulty securing labor due to the onset of harvest season for local farmers and some start-up issues with the watering system), the bioremediation process worked very well. Terramend[®] Reagent treatment succeeded despite challenges meeting moisture goals (mostly too low at first, followed by a short period with excess moisture in a low area), as well as difficulty in achieving the desired twice-weekly tilling frequency.

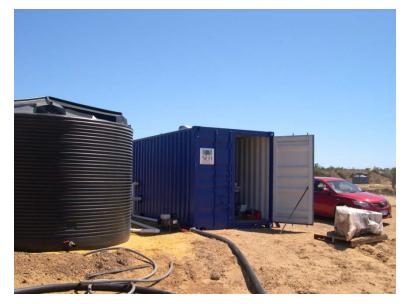
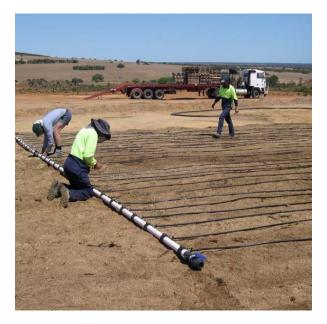
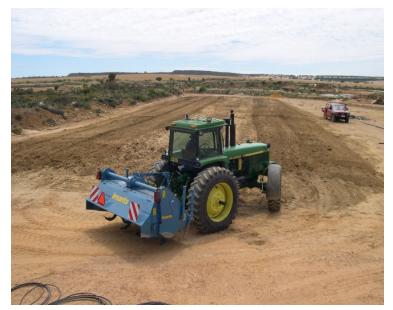
GEMEC made a series of arrangements to help ensure project success. These included:

- Procuring a specialty tiller to enable effective soil tilling operations.
- Installing an automated and removable drip irrigation system to minimize labor effort and water usage.
- Using local labor resources (e.g., irrigation contractor and farmer) to keep a close eye on the process in a very cost-effective manner.
